Manhole Inspection Summary

Manhole # S04EE2023MH

Insp Date: **8/9/06 12:00 AM**

Location Address: **3417 OLYMPIA AVE**

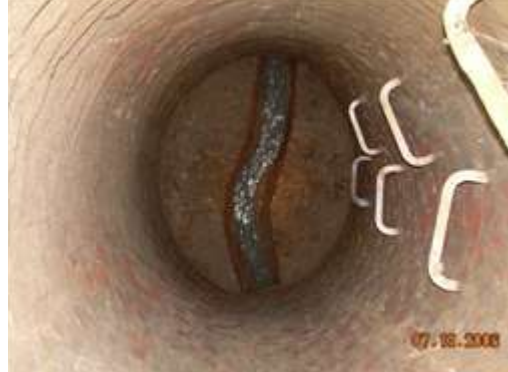
Top View

Corbel and Barrel infiltration. Evidence of surcharge - Bench debris.

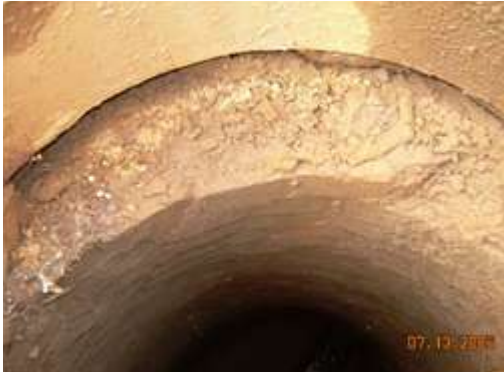
Defect

Frame leaks. Frame offset. Adjustment deterioration, loose brick and infiltration.

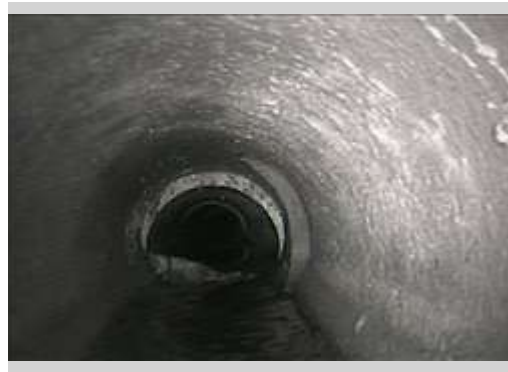
Defect

I6 offset joint.

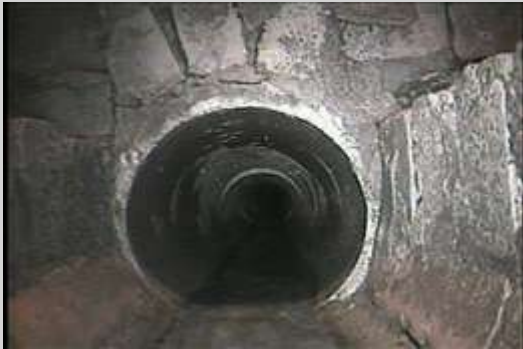
8 in. Circular Gravity Sewer Pipe Out @ 12 O'Clock

Infiltration: **Evidence** Pipe Seal Cond: **Cracked**
